# Case Study — Pikes Peak Summit Complex

## ColorGard® & S-5-V Clamp

Pikes Peak Summit Complex

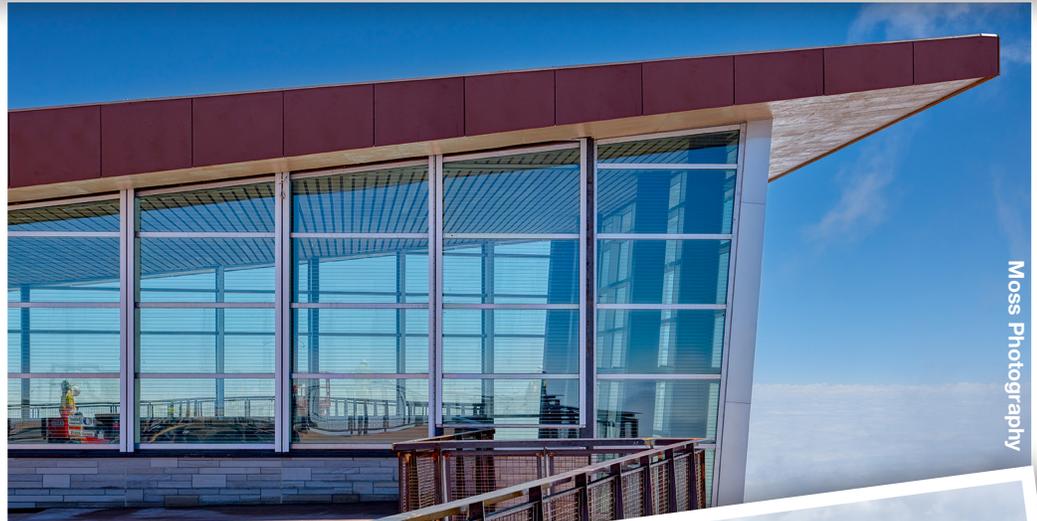
The center features a Drexel Metals 22-gauge DMC 200S, 2" mechanically seamed Corten steel standing seam metal roof with S-5! **ColorGard®** snow retention.

Having used S-5! ColorGard snow retention on a lower roof at the Pikes Peak Gateway entrance, park administrators were experienced with the product and appreciated the safety it provided. ColorGard was custom-designed and engineered to withstand the extreme winter conditions and dramatically reduces the risk of sudden and unexpected release of snow slides while providing a long-term solution for the life of the roof.
