Acapulco, México

S-5! Clamps Protect Shopping Center Roof During Hurricane Otis

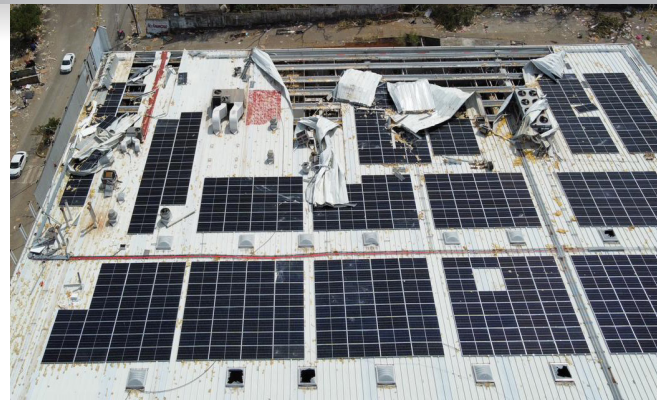
THE DEVASTATION

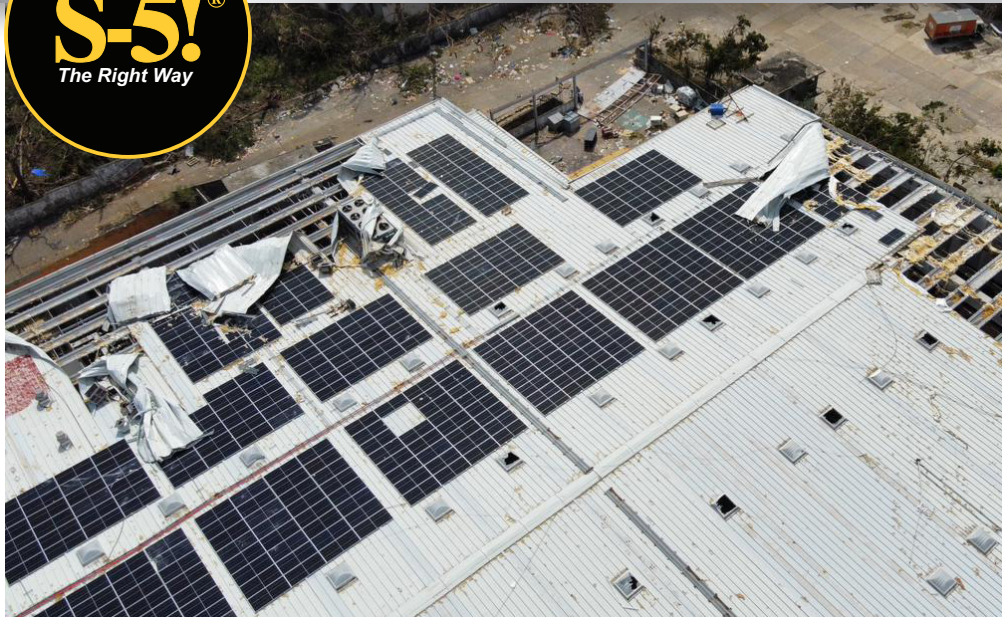
While most of the surrounding shops, restaurants, hotels and businesses were completely demolished by the category 5 hurricane, remarkably and for the most part, the Acapulco grocery store remained intact. In the aftermath of the hurricane, the roofing contractor visited the site to inspect for roof damage. Sections of the roof that were without solar experienced severe roof blow-off. However, the store's rooftop solar array secured in place by S-5! PVKITs and Mini clamps withstood the devastation.

Photos of the site taken post-hurricane clearly indicate the vast majority of roof damage was to areas of the roof without solar installed. This is evident, even in the higher-pressure edge roof zones, where the roofing panels along the edge zones, under the solar modules, were not damaged while the nearby bare roofing was blown

off. The logical conclusion is that the solar modules, PVKITS and Mini clamps installed over portions of the roof prevented those portions from failing, preserving both the solar modules and the roof.
